**Project Name:** BROWNHILLS SKIP HIRE  
**Project Description:** WinCan Import in Miraculix Standard  
**Project Date:** 24/05/2022

## Section Inspection - 17/05/2022 - F1X

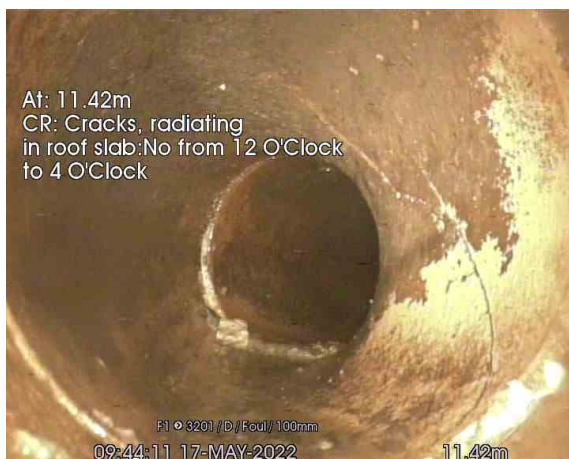
| Scale: 1:153 | Position [m] | Code | Observation | MPEG | Photo | Grade |
|---|---|---|---|---|---|---|
| | 11.42 | CR | Cracks, radiating from 12 o'clock to 4 o'clock | 00:01:02 | F1_11-42m_094411.jpg | 3 / 2 |

F1\_11-42m\_094411.jpg, 00:01:02, 11.42 m  
Cracks, radiating from 12 o'clock to 4 o'clock

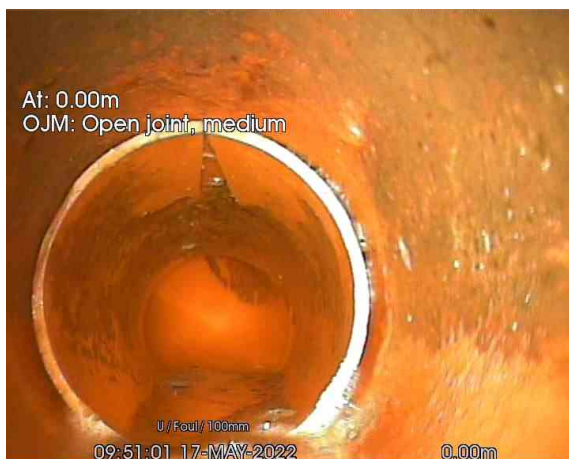
| Scale: | 1:50 | Position [m] | Code | Observation | MPEG | Photo | Grade |
|---|---|---|---|---|---|---|---|
| | | 0.00 | OJM | Open joint, medium | 00:00:16 | SVP_0-00<br>m_095101<br>.jpg | 1 |

SVP\_0-00m\_095101.jpg, 00:00:16, 0.00 m  
Open joint, medium

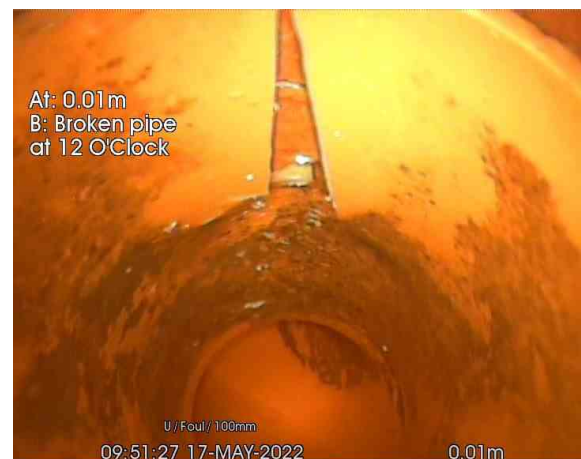
| Scale: | 1:50 | Position [m] | Code | Observation | MPEG | Photo | Grade |
|---|---|---|---|---|---|---|---|
| | | 0.01 | B | Broken pipe at 12 o'clock | 00:00:29 | SVP_0-01<br>m_095127<br>.jpg | 4 |

SVP\_0-01m\_095127.jpg, 00:00:29, 0.01 m  
Broken pipe at 12 o'clock

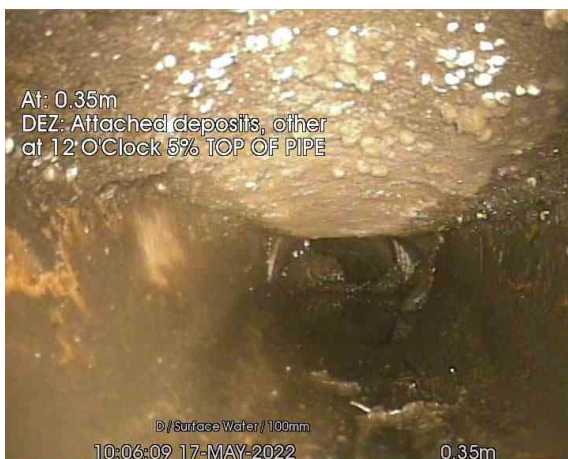
| Scale: | 1:50 | Position [m] | Code | Observation | MPEG | Photo | Grade |
|---|---|---|---|---|---|---|---|
| | 0.35 | DEZ | Attached deposits, other at 12 o'clock, 5% cross-sectional area loss: TOP OF PIPE | | 00:00:13 | GY1_0-35<br>m_100609<br>.jpg | 3 |

GY1\_0-35m\_100609.jpg, 00:00:13, 0.35 m  
Attached deposits, other at 12 o'clock, 5% cross-sectional area loss, TOP OF PIPE

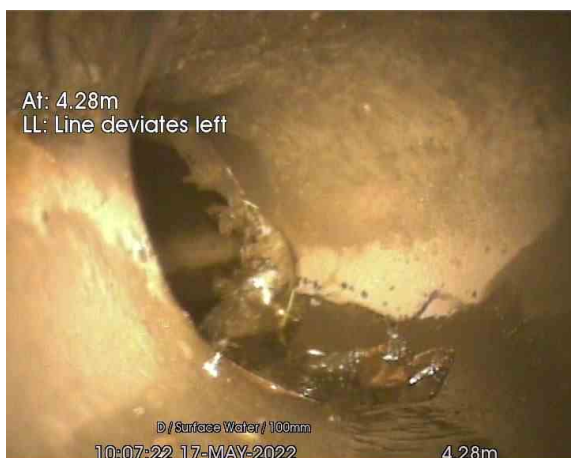
GY1\_4-28m\_100722.jpg, 00:00:51, 4.28 m  
Line deviates left

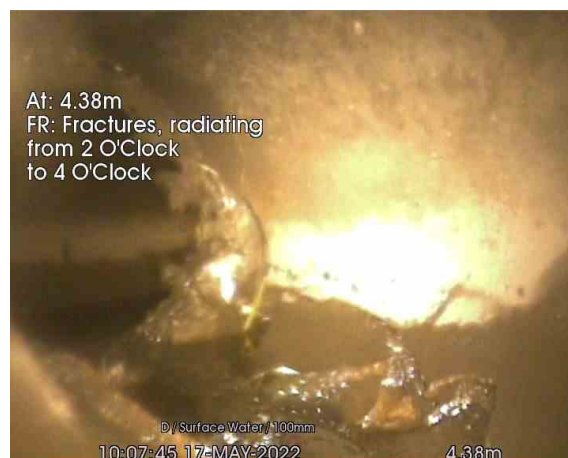
| Scale: | 1:50 | Position [m] | Code | Observation | MPEG | Photo | Grade |
|---|---|---|---|---|---|---|---|
| | 4.38 | FR | Fractures, radiating from 2 o'clock to 4 o'clock | | 00:01:04 | GY1_4-38<br>m_100745<br>.jpg | 4 / 2 |

GY1\_4-38m\_100745.jpg, 00:01:04, 4.38 m  
Fractures, radiating from 2 o'clock to 4 o'clock

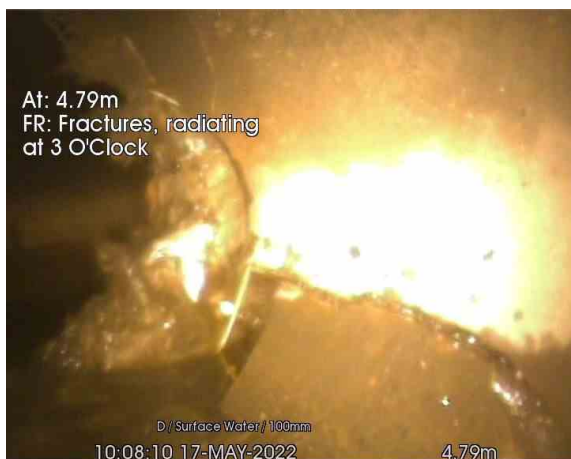
| Scale: | 1:50 | Position [m] | Code | Observation | MPEG | Photo | Grade |
|---|---|---|---|---|---|---|---|
| | 4.79 | FR | Fractures, radiating at 3 o'clock | | 00:01:21 | GY1_4-79<br>m_100810<br>.jpg | 4 / 2 |

GY1\_4-79m\_100810.jpg, 00:01:21, 4.79 m  
Fractures, radiating at 3 o'clock

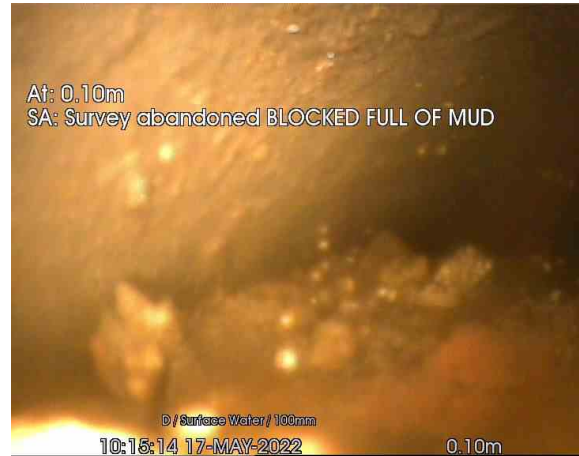
GY2\_0-10m\_101514.jpg, 00:00:42, 0.10 m  
Survey abandoned, BLOCKED FULL OF MUD

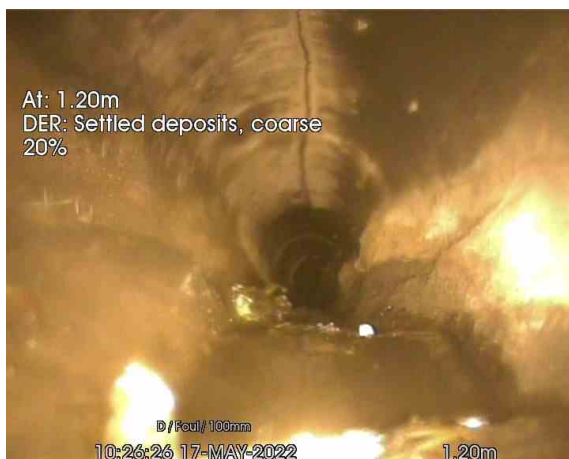
GY3\_1-20m\_102626.jpg, 00:00:16, 1.20 m  
Settled deposits, coarse, 20% cross-sectional area loss

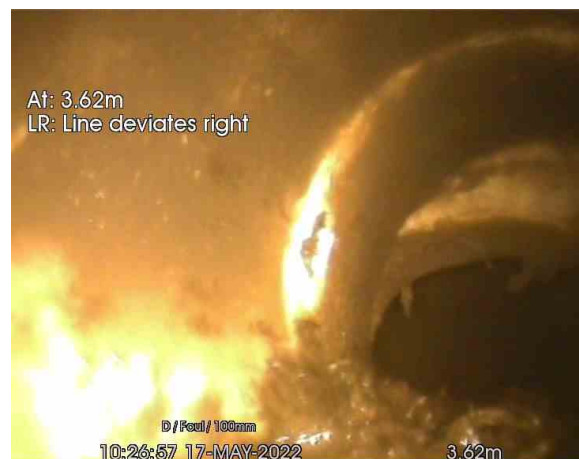
GY3\_3-62m\_102657.jpg, 00:00:41, 3.62 m  
Line deviates right

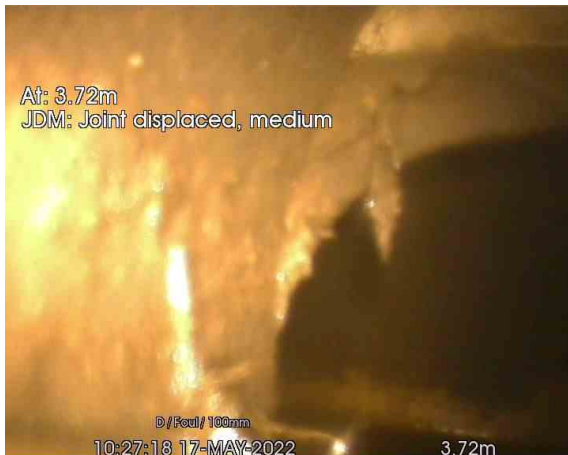
GY3\_3-72m\_102718.jpg, 00:00:55, 3.72 m  
Joint displaced, medium

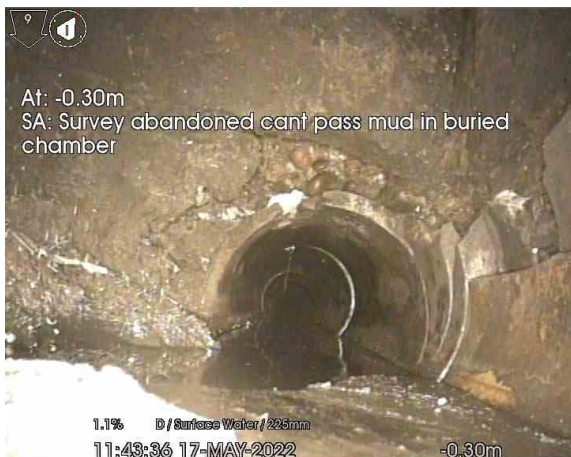
At: -0.30m  
SA: Survey abandoned cant pass mud in buried chamber

3523\_-0-30m\_114336.jpg, 00:00:13, -0.30 m  
Survey abandoned, cant pass mud in buried chamber
