APPLICATION SITE REPORT
FOR PPC APPLICATION

Envirosol Environmental Management Facility Brownhills

11/02/2008

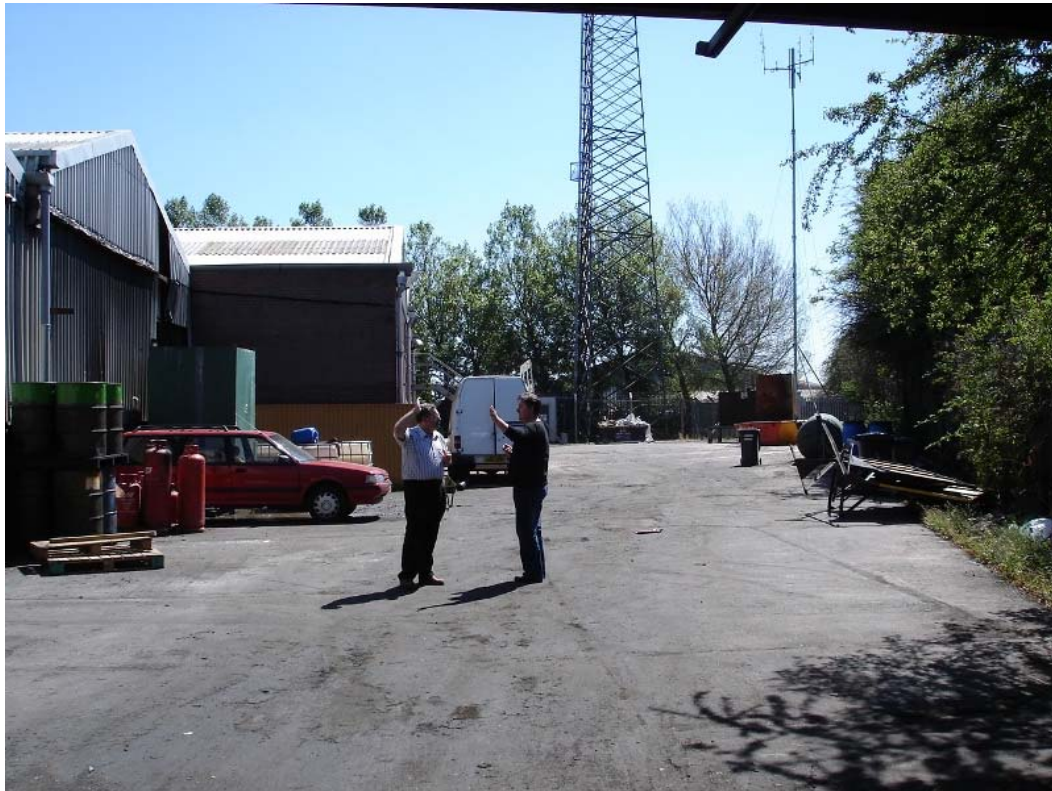
Unloading and solvent storage area

Integrity testing, other than visual inspection, has not taken place. There is no obvious cracking or damage.
